GENERAL INFORMATION OF THE CASE STUDY	
<b>Country</b>	United Kingdom
<b>City</b>	Glasgow
<b>District</b>	Yoker
<b>Climate</b>	Temperate oceanic (Cfb)
<b>Type of building</b>	Four storey tenement building, traditional stone masonry (sandstone bedded in lime mortar), plasterboard interior finishes from a 1980s refurbishment
<b>Year of Construction</b>	1910-1920
<b>Use of building</b>	Residential
<b>Classification</b>	Traditional building, not listed and not in a conservation area
<b>Type of intervention</b>	Building refurbishment: retrospective installation of an aerogel fibre insulation product, manufactured from a polyester fibre mesh impregnated with silica aerogel as insulant
<b>Suitability of intervention</b>	<p>In historic buildings, the application of external wall insulation is often inappropriate, as it can impact adversely on the exterior character of the building. Insulating internally is often also problematic, as this can impact on interior character and can reduce the usable space.</p> <p>The product developed, a loosefill material, is to be blown into existing cavities behind internal wall finishes. Using commercial blowing machines, this retrofit approach avoids any c

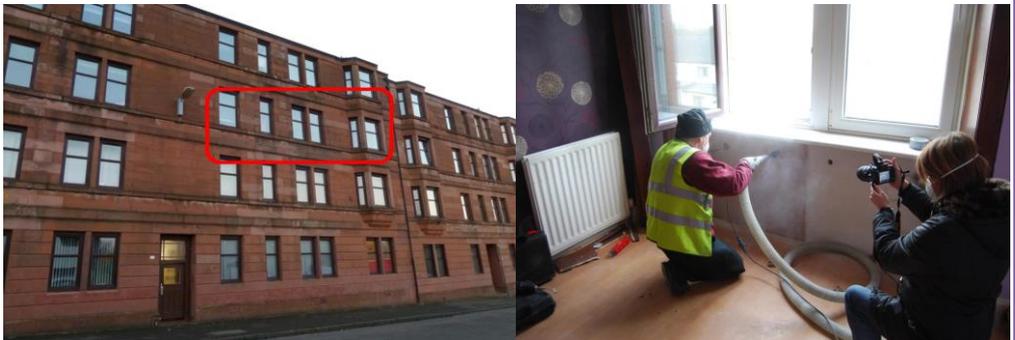
<b>Scope of intervention</b>	To demonstrate practicality of the installation under real-world conditions; to monitor the insulation's hygrothermal performance; and to test the product's reversibility
<b>Installation requirements</b>	It is recommended to blow the material with strong ventilation or vacuum cleaner, due to the dust produced during the installation.
<b>Monitoring</b>	Over a period of 10 months, heat flow, relative humidity and temperatures are being measures externally, internally and interstitially in two rooms. In one room, the insulation was installed into the internal cavities at window breasts. The other room is monitored to allow comparative assessment.
<b>Pictures</b>

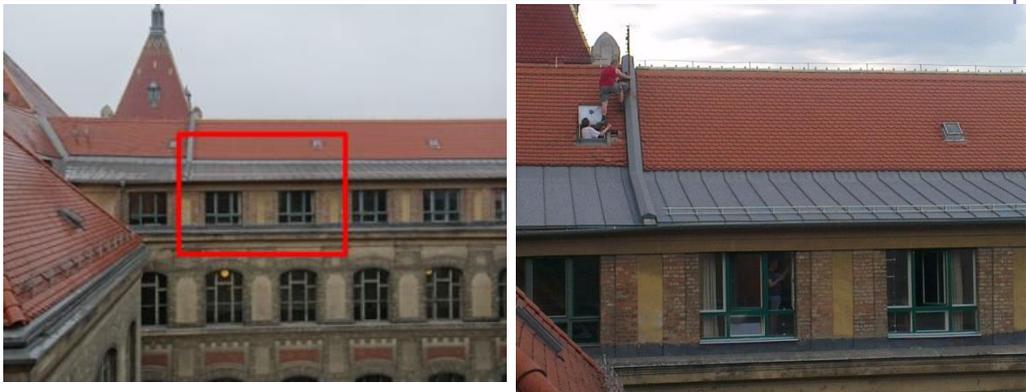
<p>The 'Pictures' section contains two side-by-side photographs. The left photograph shows a wide view of a multi-story building with a red-tiled roof and a prominent central tower. A red rectangular box highlights a section of the facade with several windows. The right photograph is a closer view of the roof and the windows below it, showing a person on the roof and the details of the window frames and the new ventilation system components.</p>

<b>Scope of intervention</b>	To evaluate the performances of the developed windows and the impact of the intelligent management of lighting and heating through energy consumption differences in the demo and reference rooms.
<b>Installation requirements</b>	In order to install intelligent indoor climate solutions, the building should be equipped with a BMS (Building Management System)
<b>Monitoring</b>	The monitoring system installed at Budapest has been developed to specifically measure the performance of the newly developed windows. The monitoring of the indoor comfort parameters (air temperature, relative humidity, lux and CO <sub>2</sub> ) and the electrical/thermal energy consumption has been integrated in the Building Management System
<b>Pictures</b>

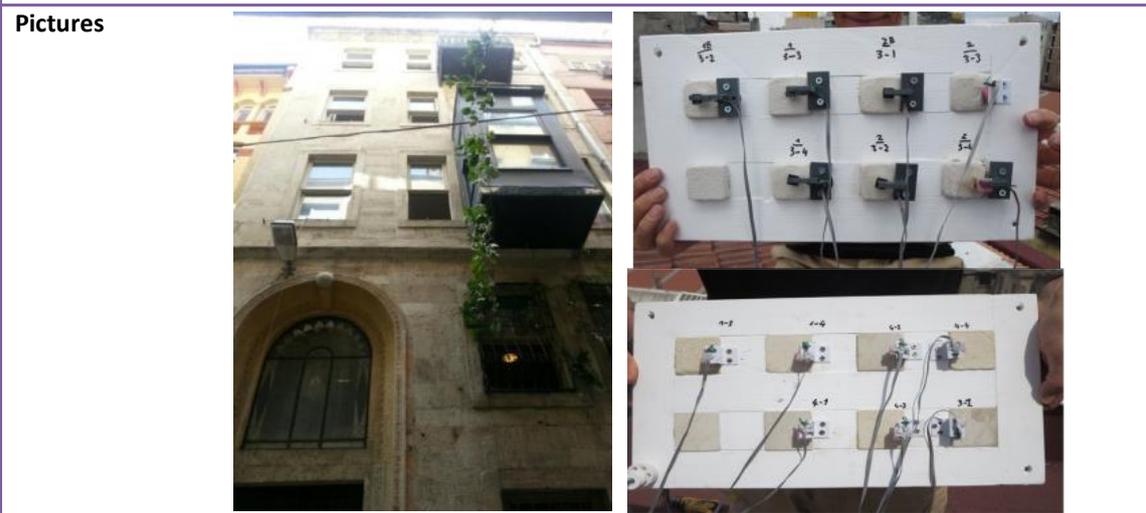
<b>Scope of intervention</b>	To evaluate the applicability of the product on historic buildings materials in real environmental conditions and to evaluate the energetic performances of the coating.
<b>Installation requirements</b>	The complete reversibility of the coating can be guaranteed only on some substrates, depending on its porosity and roughness. The coating has better performance if applied on large opaque surface
<b>Monitoring</b>	The monitoring system will evaluate the performance of the coating by measuring air temperature, relative humidity and contact temperature.

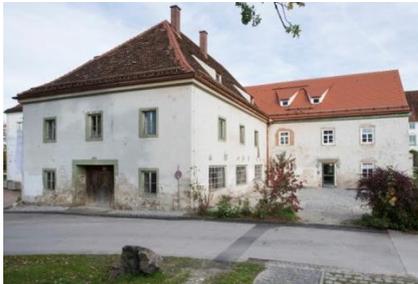
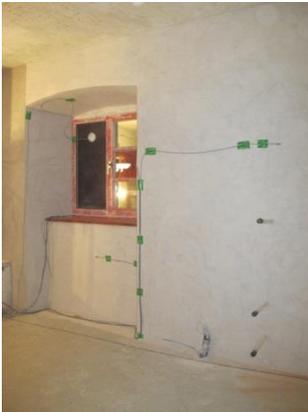
<b>Scope of intervention</b>	To evaluate the applicability, workability and reversibility of the product in real conditions and to measure the energetic improvements.
<b>Installation requirements</b>	The mortar can be applied in a conventional way. To have a good adhesion existing plaster should be removed or treated with commercial products. If the wall is not flat, the mortar should be applied in two cycles.
<b>Monitoring</b>	Energy consumption and environmental conditions will be compared before and after the intervention. The monitoring system comprises air and surface temperature, humidity sensors, heat flux and radiation.
<b>Pictures</b>
